BLM Cedar City Field Office Site Inspection Report

November 18, 2013

UTU-78619

Wah Wah Red Beryl Prospect

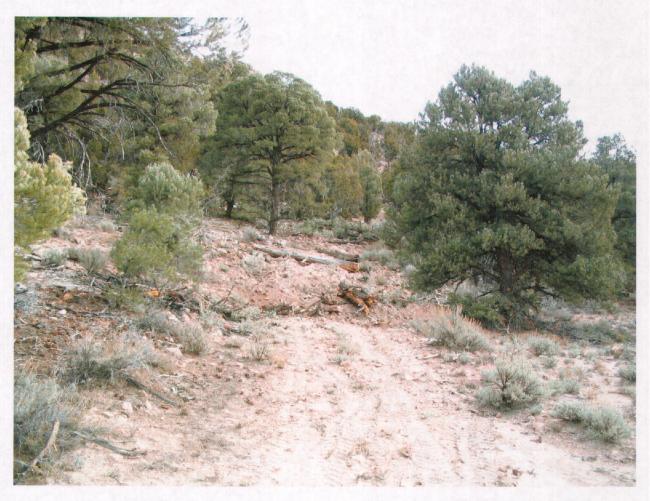
UTU-78619: Wah Wah Prospect November 15, 2013

View, looking easterly, of reclaimed point of beginning of the new access trail created under the notice.

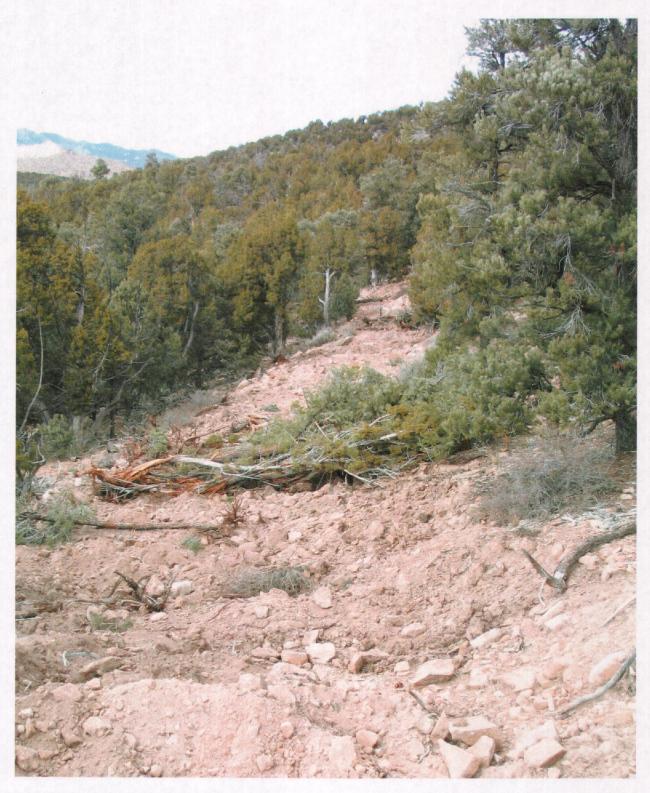
UTU-78619: Wah Wah Prospect November 15, 2013

View, looking northerly, of typical section of the reclaimed access trail between its point of beginning and the former access gate.

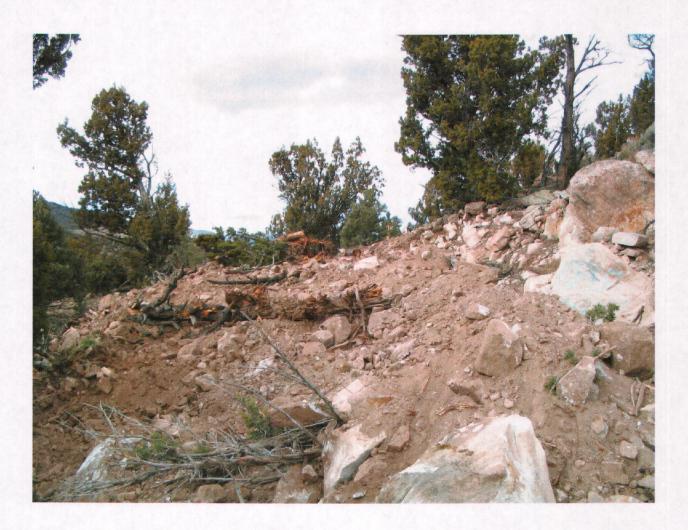
UTU-78619: Wah Wah Prospect November 15, 2013

View, looking northwesterly, of former location of the access gate.

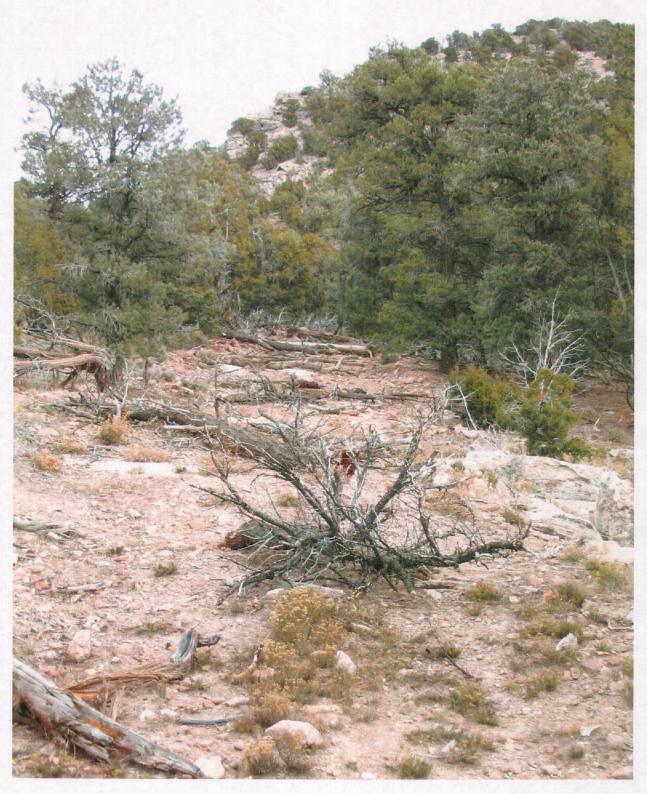
UTU-78619: Wah Wah Prospect November 15, 2013

View, looking easterly, of typical section of the reclaimed access trail between the former gate and the prospect.

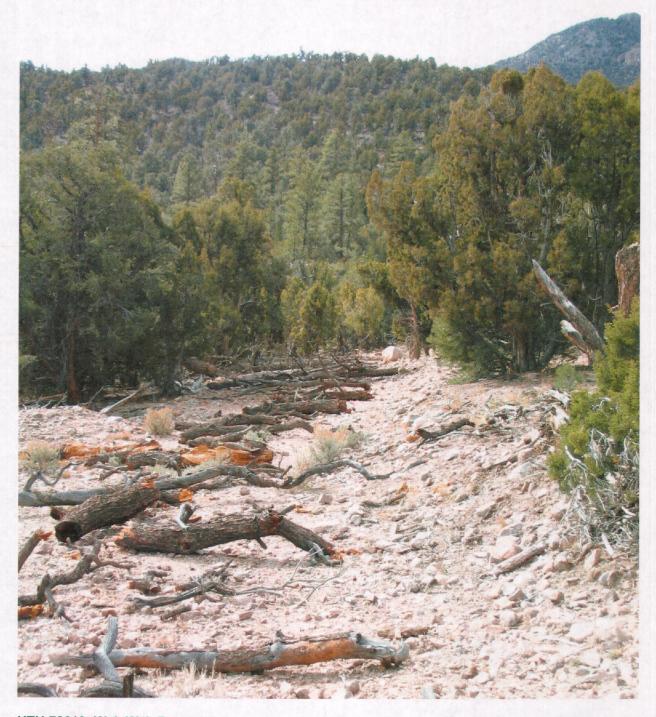
UTU-78619: Wah Wah Prospect November 15, 2013

View, looking easterly, of typical section of the reclaimed access trail between the former gate and the prospect.

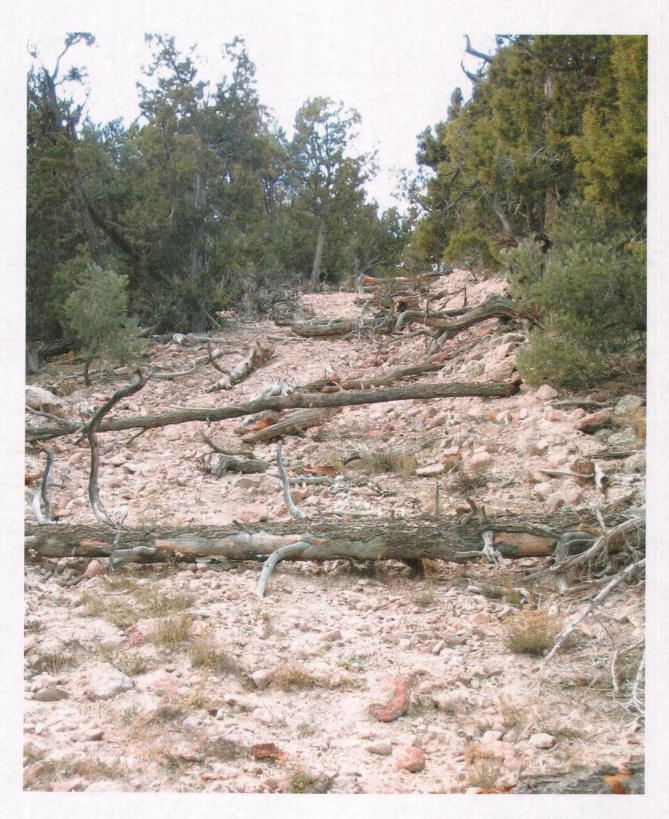
UTU-78619: Wah Wah Prospect November 15, 2013

View, looking westerly, of typical section of the reclaimed access trail between the former gate and the prospect.
